NONDESTRUCTIVE METHODS FOR EVALUATING DAMAGE EVOLUTION AND MATERIAL BEHAVIOR IN METAL MATRIX COMPOSITES

February 1997

Final Technical Report

Grant No. F49620-93-1-0461

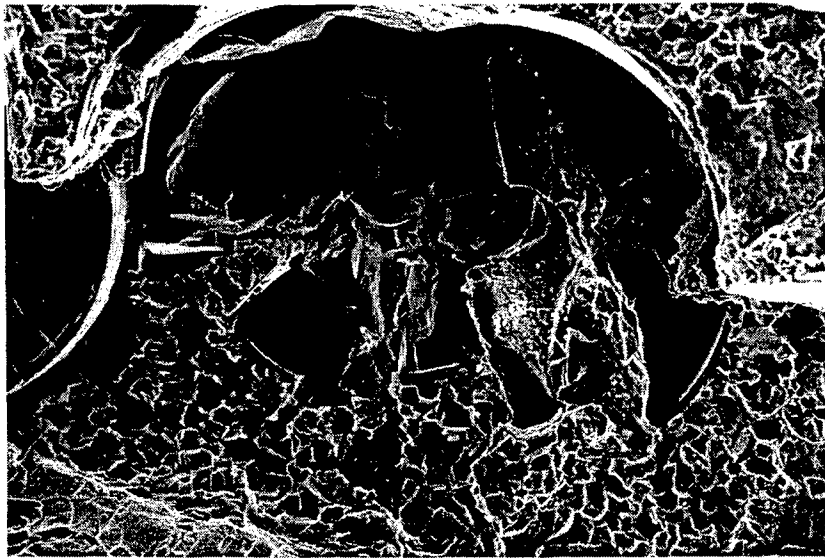
Figure 100. Smashed fiber on fracture surface. Matrix is consolidated around shards indicating fiber failure during consolidation of composite, prior to mechanical testing.
